## dsPIC33EPXXGS50X Family Silicon Errata and Data Sheet Clarification

The dsPIC33EPXXGS50X family devices that you have received conform functionally to the current Device Data Sheet (DS70005127D), except for the anomalies described in this document.

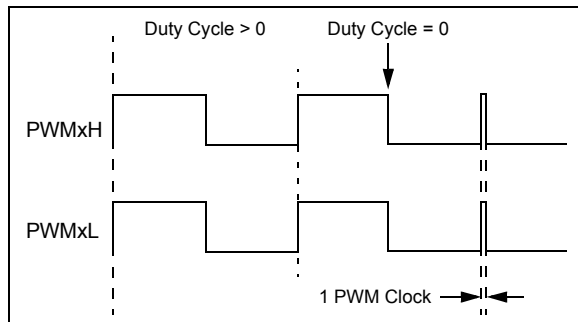
**FIGURE 1: EXAMPLE FOR REDUNDANT OUTPUT MODE**

In the Redundant Output mode (IOCONx[11:10] = 0b01) and Push-Pull Output mode (IOCONx[11:10] = 0b10), with the Immediate Update Enable bit disabled (PWMCONx[0] = 0), when the Duty Cycle register is updated from a non-zero value to zero, a glitch pulse of a width equal to one PWM clock will appear at the next PWM period boundary, as shown in Figure 1 (for the Redundant Output mode). The Duty Cycle register refers to the PDCx register if PWMCONx[8] = 0 or the MDC register if PWMCONx[8] = 1.

If the application requires a zero duty cycle output, there are two possible work around methods:

1. Use the PWM override feature to override the PWM output to a low state instead of writing to the Duty Cycle register. In order to switch back to a non-zero duty cycle output, turn off the PWM override. The override-on and override-off events must be timed close to the PWM period boundary if the IOCONx register has been configured with IOCONx[0] = 0 (i.e., output overrides through the OVDDAT[1:0] bits occur on the next CPU clock boundary).
2. Enable the Immediate Update Enable bit (PWMCONx[0] = 1) while configuring the PWMx module (i.e., before enabling the PWMx module, PTCON[15] = 1). With the Immediate Update enabled, writes to the Duty Cycle register can have an immediate effect on the PWM output. Therefore, the duty cycle write operations must be timed close to the PWM period boundary in order to avoid distortions in the PWM output.
